CO₂-SCC in Flexible Pipe Carbon Steel Armour Wires

R. de Motte, G. Joshi, T. Chehuan, R. Legent, J. Kittel, N. Désamais

R. de Motte, G. Joshi, T. Chehuan, R. Legent, J. Kittel, et al.. CO₂-SCC in Flexible Pipe Carbon Steel Armour Wires. *Corrosion*, 2022, 78 (6), pp.547-562. 10.5006/4025 . hal-03748596

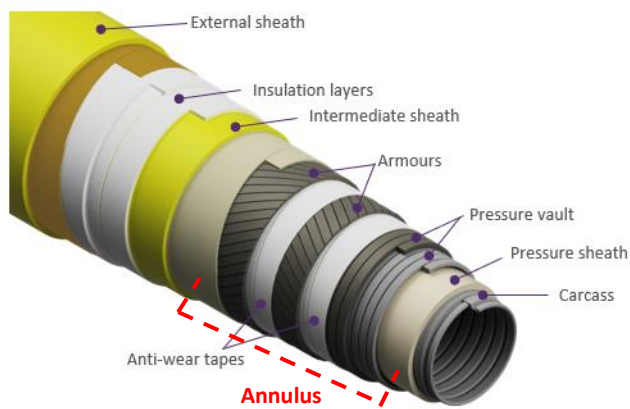
Figure 1.

Flexible pipes have been used by the oil and gas industry in offshore applications for many decades in the transportation of fluids. As shown in Figure 1, these complex pipelines are comprised of both polymer and steel layers; each layer independent but essential in its interaction with one another and fit-for-purpose¹. Carbon steel wires, present in the annulus region of the flexible pipe, are essential in providing the structure its high pressure and tensile load resistance. However, due to permeation, some of the components in the bore fluid can enter the annular space thus creating a corrosive environment for the carbon steel wires. Corrosive gases such as CO₂ and H₂S are present in the annulus dissolved in either condensed water, which permeates through the polymer pressure sheath, or seawater, as a result of damage to the external sheath. The extent of the corrosive nature of the annulus environment is dependent on the permeation rate and equilibrium pressure of acid gases².

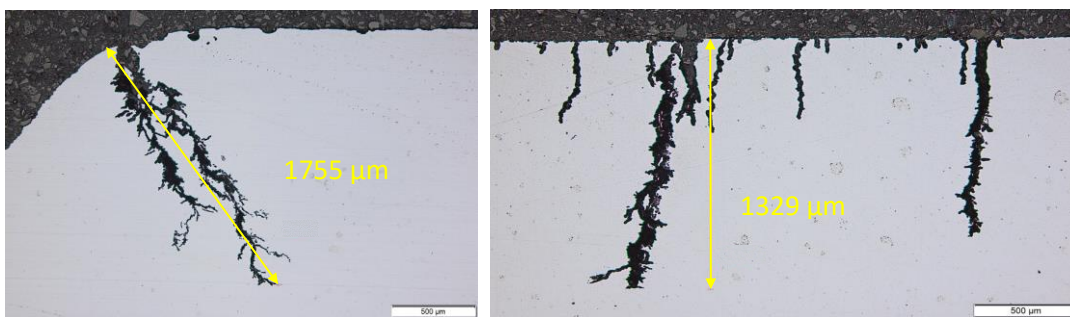
Figure 2.

FIGURE 2. SEM images of typical CO₂-SCC cracks observed on flexible pipe armour wires retrieved from service operating in medium to high CO₂ environments (> 50 bar fCO₂ in the bore).

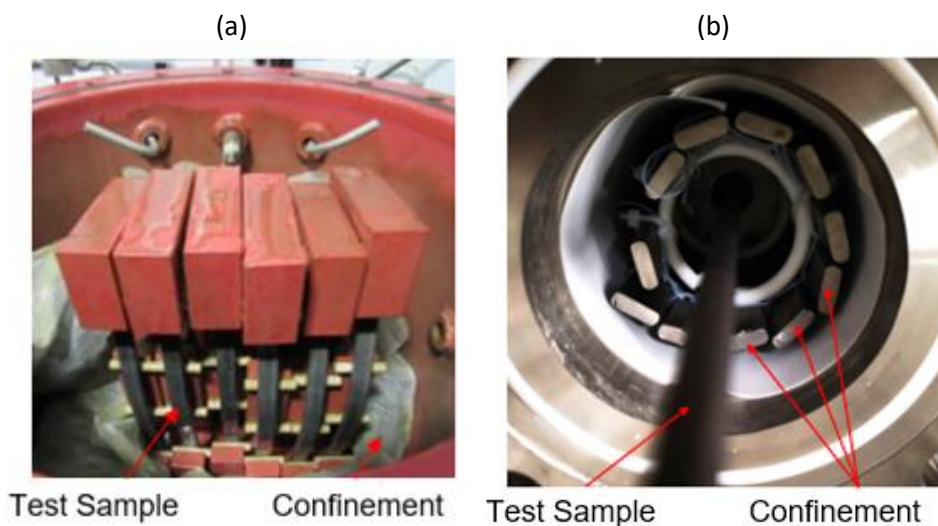
Figure 3.

6
7
8 The test campaign presented in this article considers two small scale applied load test methods with two different configurations: four-
9 point bending (4pB) and tensile load. Both test methods are widely used in the oil and gas industry to evaluate the resistance of metals to sulfide
10 stress cracking (SSC) and stress corrosion cracking (SCC) ^{26,27}. As shown in Figure 3 (a), 4pB test is a constant displacement test that is performed by
11 supporting a test specimen on two loading rollers and applying a load through two other loading rollers so that one face of the specimen is in
12 tension (uniformly stressed between the inner rollers) and the other is in compression. On the other hand, tensile load tests are constant load tests
13 used to evaluate a test specimen for environmentally assisted cracking (EAC) resistance under uniaxial tensile loading where dead weight, proof
14 ring or hydraulic loading may be applied. Figures 3 (a) and (b) show a photo of the interior of an open autoclave prior to testing for a 4pB test and

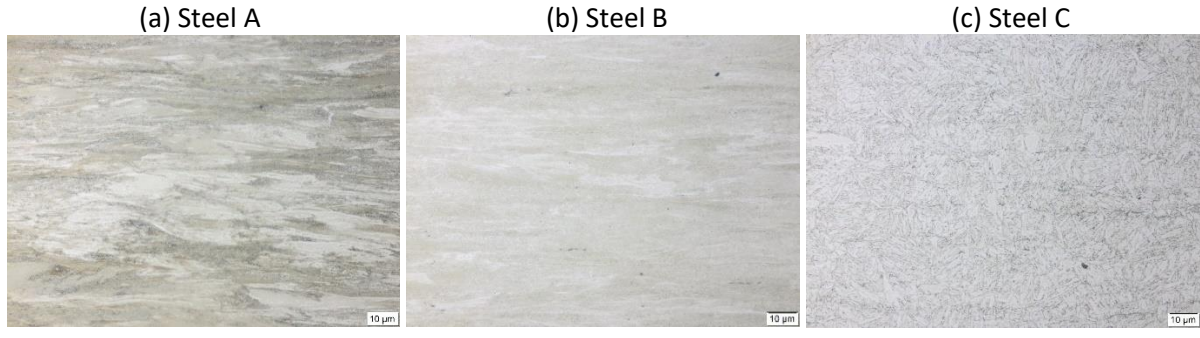
Figure 4.

FIGURE 4. SEM Images of the cross-sectional microstructure of the different material steels studied (a) Steel A (b) Steel B (c) Steel C. Microstructure was obtained after etching in a 10% nital solution.

50 Almost all existing wire grades have been tested and studied as part of this work. However, in the following article, the results from three
51 tested armour wire materials (Steel A, B, C) are presented and discussed. The differences between the three steels are shown in Table 1 and Figure
52 4 shows their cross-sectional microstructure.
53
54
55
56
57
58
59
60

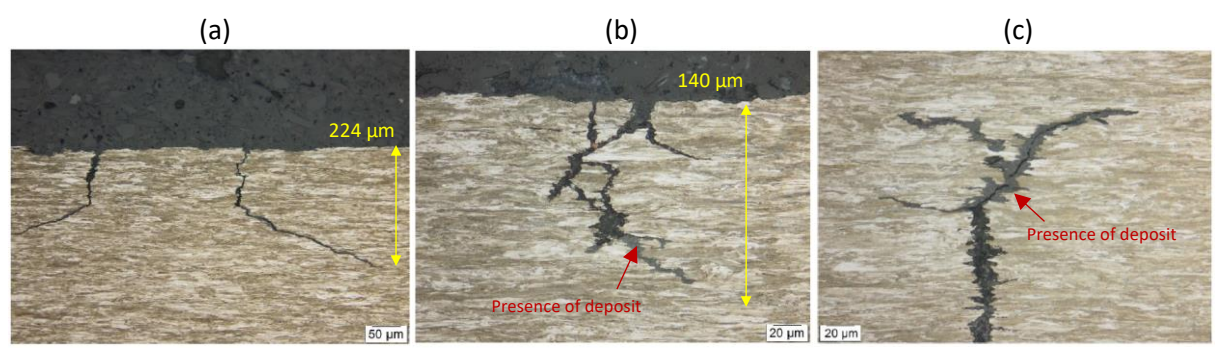
Figure 6.

FIGURE 6. Microscope images identifying SCC crack profiles observed on Steel A tested under tensile load at 100% of the AYS and at conditions 40°C, 6 bar fCO₂.

28
29
30 In all tests carried out within this work, cracks observed on the surface of tested samples (after scale removal) are systematically analyzed
31 to identify the crack profile. Figure 6 shows photos of cracks that were observed only on the non-immersed region of a tested sample under tensile
32 load as no cracks were observed on the immersed region. The test was carried out over a duration of 6 months, at 6 bar fCO₂, 40°C, with an applied
33 load of 100% of the AYS and on material grade Steel A. The specimens were etched (Nital) to reveal the microstructure and the relationship
34 between corrosion, microstructure and crack path. For the following test, very limited corrosion was observed across the tested sample with no
35 evidence of pits/ localized corrosion in the non-immersed region. The immersed region of the tested sample was observed to be relatively more
36 corroded with a few observations of localized corrosion/ pits. It is important to note that the relatively higher corrosion in the immersed region of

37 the samples is evident for all tests and can be attributed to the differences in confinement between the two regions of the sample. The cracks
38 shown in Figure 6 are representative of the different crack profiles observed across the non-immersed region of the sample. In general, they were
39 either found to be relatively thin and branched with the presence of secondary cracks as in the case of Figure 6 (a) or showed evidence of
40 preferential dissolution of ferrite along the crack path as shown in Figures 6 (b, c). All cracks were observed to initiate relatively from the surface of
41 the sample. Furthermore, as shown in Figures 6 (b) and (c), corrosion precipitates in the more profound cracks that formed during crack
42 propagation were not completely removed during inhibited acid descaling. Figure 7 shows the results of EDX analysis carried out on a magnified
43 image of the deposit identified within the crack path, with an atomic percent matching that of FeCO₃. The presence of this protective deposit may

The final parameter presented and discussed in this article is the impact of $f\text{CO}_2$. CO_2 fugacity has been observed to be critical to SCC testing, and along with applied stress, is considered to be the defining parameters for the development of CO_2 -SCC free domains. Over the last few years, through a large volume of applied load tests carried out, CO_2 -SCC cracks have been successfully reproduced on all material grades used by TechnipFMC in standard flexible pipe design with tensile or 4pB testing configuration. Results have shown that the SCC risk increases with an increase in $f\text{CO}_2$ with some materials being more resistant than others. Furthermore, at 100% of the AYS, all material grades were observed to be susceptible to CO_2 -SCC for a CO_2 fugacity greater than or equal to 15 bar. This shows a significant contradiction with the work done by Santos et al.³² where 4pB test results showed no CO_2 -SCC on a material grade tested at 80 bar $f\text{CO}_2$ and with an applied load at 100% of the AYS. It is believed that the reason behind this difference from our results may be linked to differences in the experimental set-up and sample preparation. Furthermore, the article³² shows no indications of SCC on a high strength sweet service wire tested at conditions of 10 bar and 40°C after a period of 180 days. In our work, CO_2 -SCC cracks were observed in sweet service, high strength wires (Steel A) in tests carried out with as low as 3 bar $f\text{CO}_2$ as shown in Figure 18 (a). The figure shows two selected cross-sectional microscope images that are believed to be representative of the overall cracks observed along the surface at 3 bar and 6 bar respectively. It is to be noted that cracks were observed only in the non-immersed region of the sample. Both tests were tensile load tests carried out on Steel A, at 40°C, 100% of the AYS and over a duration of 6 months. Figure 18 shows an interesting impact of $f\text{CO}_2$ on the crack morphology for the tested steel grade. It was observed that for the same material grade, increasing the $f\text{CO}_2$ resulted in finer, more branched cracks with relatively lower preferential dissolution along the crack path. Figure 6 shows additional images for the same test shown in Figure 18 (b).

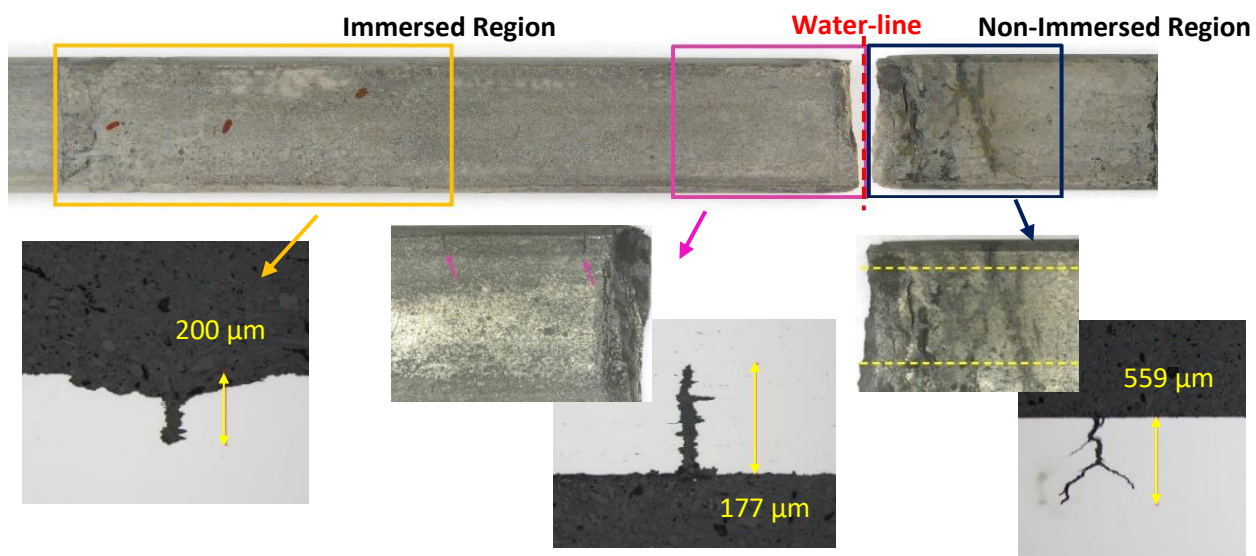
Figure 15.

The impact of this parameter is further shown through the results of two tensile load tests in Figures 15 and 16. Figure 15 shows results from a test carried out on material grade Steel B with an applied stress of 95% of the AYS and at 40°C, 6 bar fCO₂. The test ended after 4.5 months due to the rupture of the test sample at the water line. In the following test, cracks have been observed in both regions of the sample. The cracks in

1 the immersed region of the sample were observed to have a maximum depth of 200 μm and comparatively thicker than that observed in the non-
2 immersed region. Furthermore, cracks were observed to initiate from pits due to higher levels of under-deposit, localised corrosion. In the non-
3 immersed region, the cracks were thinner and more branched with depths of approximately 630 μm closer to the rupture face. Figure 16, on the
4 other hand, shows an example of a test where cracks were only observed on the non-immersed region of the test sample. This particular tensile
5 load test was carried out on material grade Steel C with an applied load stress of 100% of the AYS and at 40°C, 15 bar $f\text{CO}_2$. As shown in the figure,
6 a large density of CO_2 -SCC cracks was observed in the non-immersed region which were found to be quite thin and deep with minimal branching. In
7 the immersed region, no cracks were observed. In the following test, a relatively low-level of corrosion was observed throughout the entire test

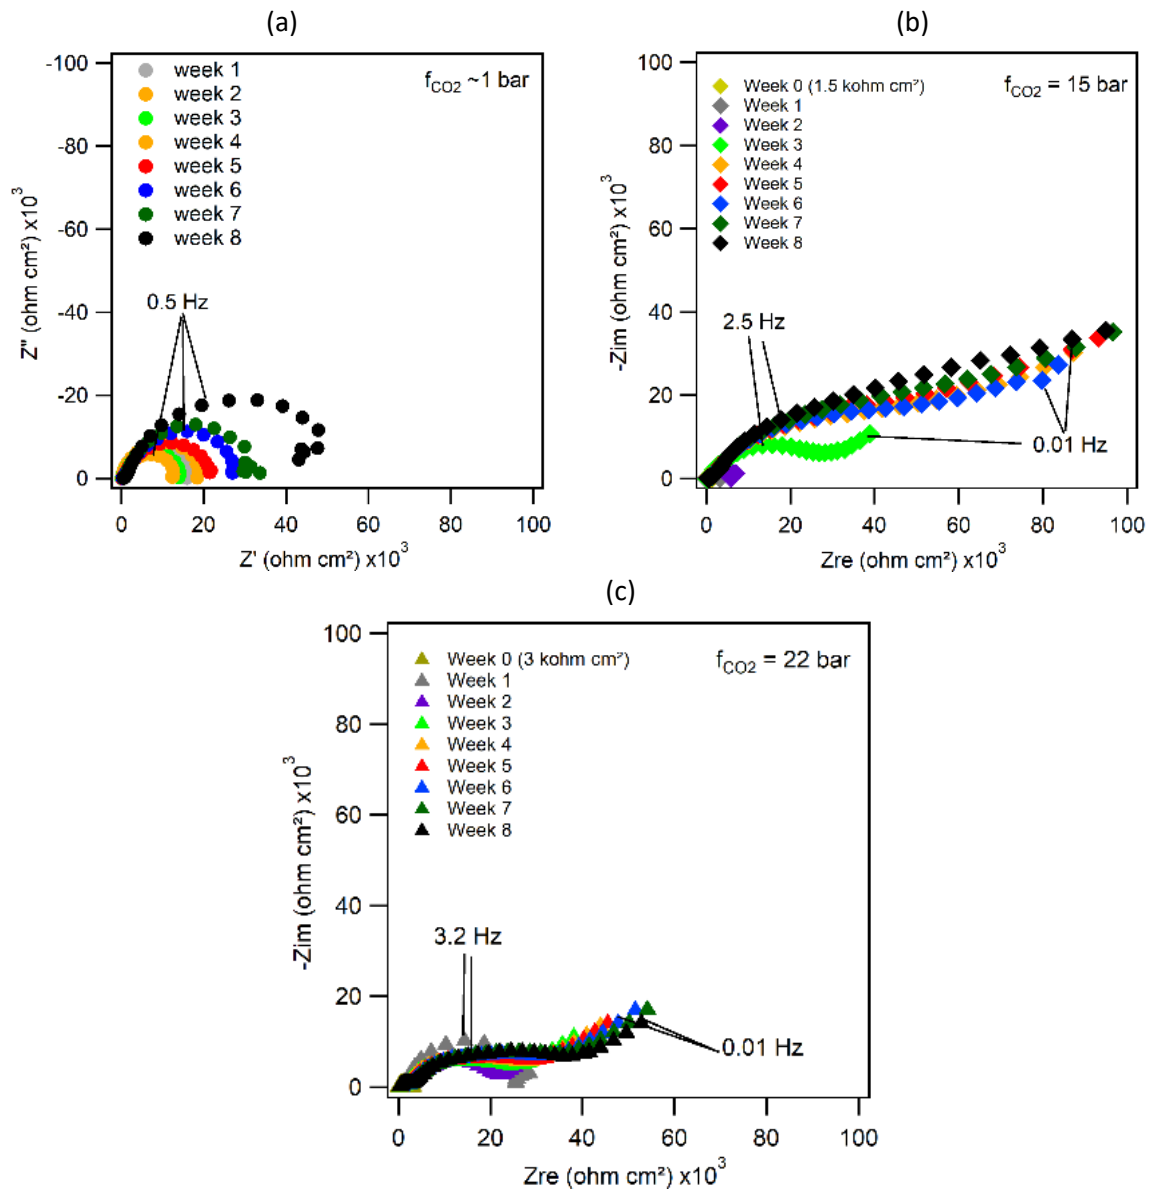
Figure 19 shows the impedance curves for Steel C tested over a duration of 8 weeks at 40°C, $V/S = 1 \text{ mL/cm}^2$ at 1 bar $f\text{CO}_2$, 15 bar $f\text{CO}_2$, and 22 bar $f\text{CO}_2$. The results show that a single capacitive semi-circle is observed for the entire test duration for the test at 1 bar $f\text{CO}_2$, with no linear tail evident at low frequency. Figures 19 (b) and (c) depict impedance curves for Steel C at 15 and 22 bar $f\text{CO}_2$ respectively. These test results show that an increase in $f\text{CO}_2$ results in a more rapid formation of a pseudo-passive protective overlayer. For a test duration of 8 weeks, it has been shown that a protective pseudo-passive film does not form at 1 bar (Figure 19(a)) and forms after 6 weeks, 3 weeks, 2 weeks for 10 bar (Figure 17), 15 bar and 22 bar (Figure 19 (b) and (c)) respectively confirming a faster film formation kinetics with an increasing $f\text{CO}_2$. The rapidity of the transition to a pseudo-passive state appears to be an important parameter towards the severity in CO_2 -SCC crack observations. Furthermore, in conditions where a linear tail is formed, the modulus of the total impedance at 1 mHz is observed to be approximately $1000 \times 10^3 \Omega \cdot \text{cm}^2$, $120 \times 10^3 \Omega \cdot \text{cm}^2$ and $55 \times 10^3 \Omega \cdot \text{cm}^2$ thus showing a decrease with an increase in $f\text{CO}_2$. This again goes to suggest that despite the more rapid formation of a pseudo-passive protective film, it may be of poorer characteristics (i.e. more permeable) thus increasing the susceptibility to CO_2 -SCC. A rather important aspect observed in Figure 19 is that the impedance curves after a period of 6 weeks start to overlap/ superimpose. This is interpreted as the establishment of an interface that is stable and at a steady state with the surrounding solution chemistry. Such EIS observations suggest that the interface will not continue to develop to a great extent over a longer duration of testing.
