# Effect of degraded environmental conditions on the service behavior of a X65 pipeline steel not designed for hydrogen transport

C. Mendibide, F. Vucko, M. Martinez, G.R. Joshi, J. Kittel

C. Mendibide, F. Vucko, M. Martinez, G.R. Joshi, J. Kittel. Effect of degraded environmental conditions on the service behavior of a X65 pipeline steel not designed for hydrogen transport. *International Journal of Hydrogen Energy*, 2024, 52 (Part A), pp.1019-1032. 10.1016/j.ijhydene.2023.05.309 . hal-04431257

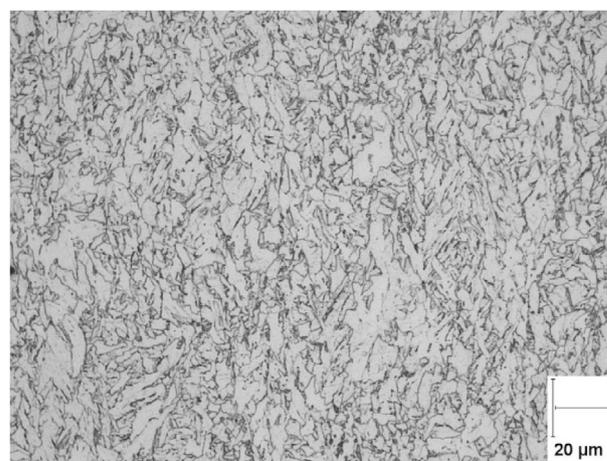
**Fig. 1 – Microstructure of the studied  $\times 65$  steel after Nital Etching.**

The grade has a ferritic microstructure with pearlite at grain boundaries (Fig. 1). No macro-segregations are visible after nital etching (2% nitric acid in ethanol).

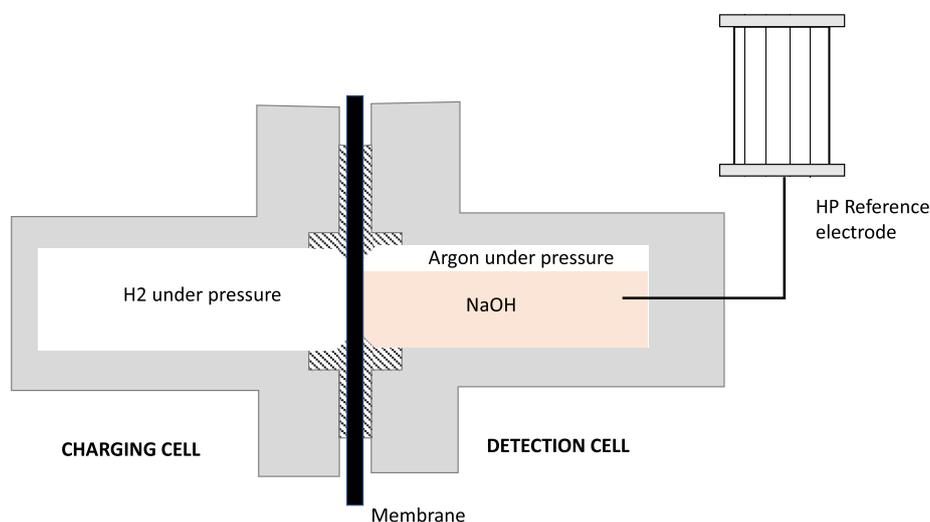
Fig. 2 – Schematic of the electrochemical H-permeation Devanathan-Stachurski cell.

The following test protocol was employed. The membrane was first polished to 1200-grit SiC paper. The membrane is then set-up in the permeation cell before completing a leak test with pressurized helium. The exit surface of the membrane is then pickled in concentrated inhibited HCl inhibited with hexamethylenetetramine (corrosion inhibitor) and then coated with palladium. This coating is applied through electrodeposition using a solution containing 5 g/L of  $\text{PdCl}_2$  in ammonia 28% under a galvanostatic polarization at  $-2 \text{ mA/cm}^2$  for 90 s. After rinsing with demineralized water, the 0.1 M NaOH solution used for electrochemical extraction is introduced in the detection side and the cell is pressurized to 50 bar using Argon. This pressure is just below the maximum operating pressure of the reference electrode. The membrane is then polarized to +100 mV/Ag/AgCl until a background current density not higher than some tens of  $\text{nA/cm}^2$  is measured. The charging cell is then vacuumed using a pump and loaded at 100 bar with the gas of interest (100% $\text{H}_2$  or “99%  $\text{H}_2$  + 0.9% Ar + 0.1%  $\text{H}_2\text{S}$ ”) and the permeation flux monitored. In all experiments, the detection cell was pressurized at 50 bar which ensured that any deformation of the membrane by pressurization of the charging cell remains in the elastic range of the tested material. The increase in pressure was completed “step-by-step” in both cells to equilibrate the pressures during experiment start. Subsequently, hydrogen oxidation current was tracked over 150 h.

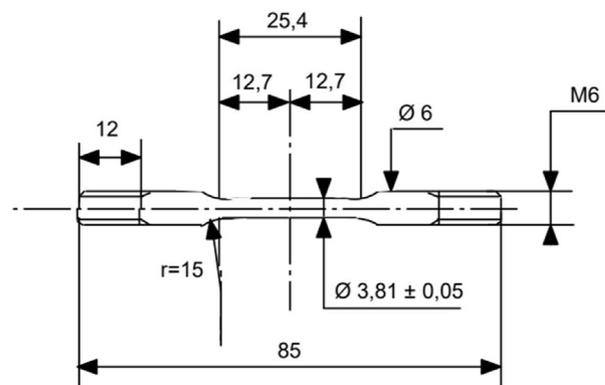
**Fig. 3** – Schematic of the specimen used in the SSRT experiments (dimensions in mm).

Published data on  $\times 80$  pipeline steel underline that embrittlement can be observed on smooth tensile specimens [25,53]. On this basis, and to evaluate the susceptibility of the material to crack initiation, slow strain rate tests were conducted on smooth tensile samples machined in the longitudinal direction. A slow strain rate test bench was set-up with an autoclave containing a tensile specimen. The same start-up procedure as the one described in section Hydrogen induced cracking (HIC) tests was considered. After pressurizing the autoclave with the gas, the specimen was loaded to failure at a fixed extension rate of  $10^{-6} \text{ inch s}^{-1}$ . In all experiments, a NACE subsize specimen machined as per the schematic in Fig. 3 was used.

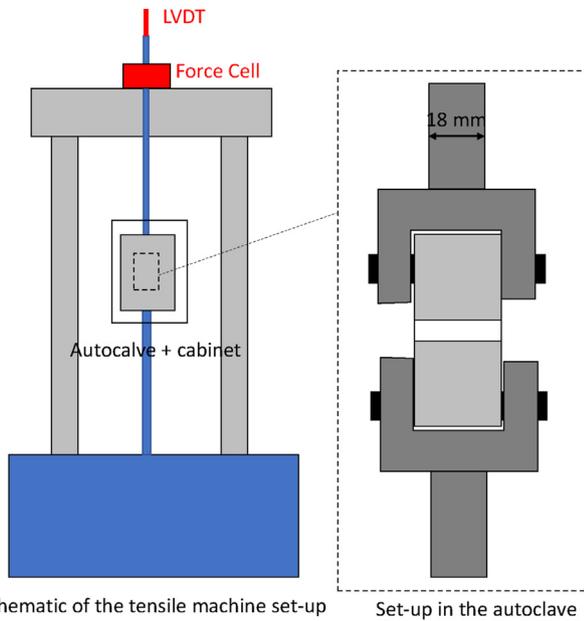
**Fig. 4 – Schematic presentation of the test set-up for fracture toughness evaluation.**

conducted. For each test, the specimens were set-up in an autoclave fixed on a tensile machine as schematically presented in Fig. 4. A displacement and force monitoring are ensured at the top of the loading line using calibrated linear variable differential transformer (LVDT) sensor and force cells (outside the autoclave). The autoclave is placed in a sealed polycarbonate cabinet flushed with nitrogen during the test to avoid hydrogen ignition during the loading in case of leak.

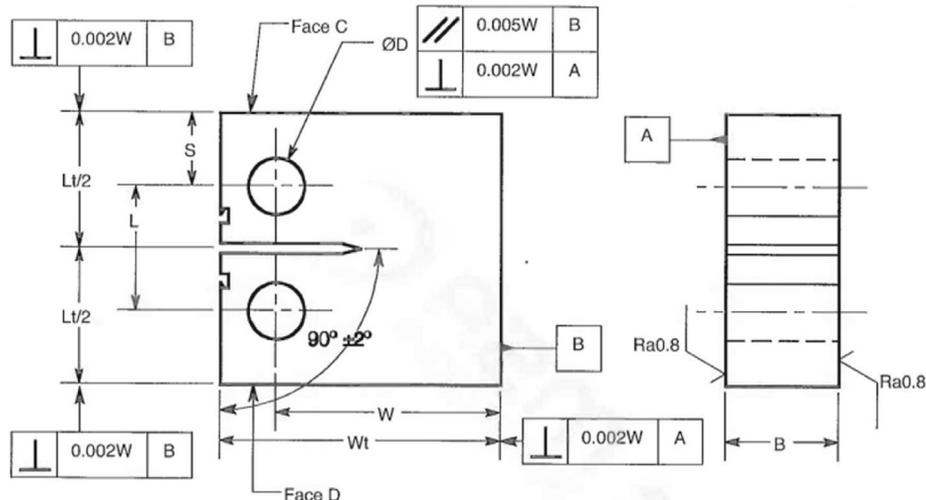
**Fig. 5 – Sketch of a standard CT B15/W30 specimen.**

- $a_0$  the initial crack length measured through fractographic observations considering a minimum of 5 measurements.
- B, W, the dimensions of the CT specimen used (see Fig. 5)
- P the force at failure.

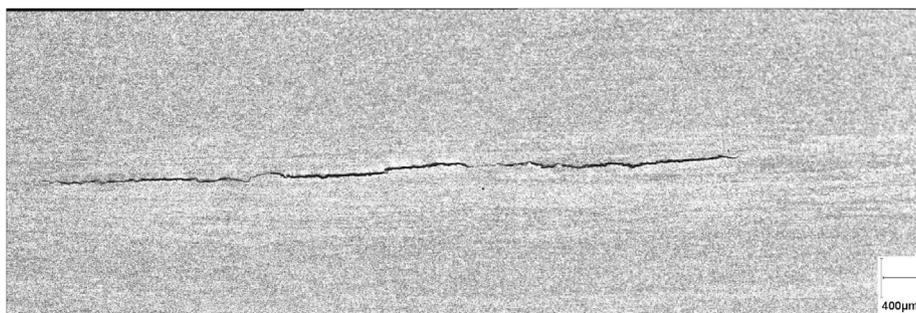
Fig. 6 – Example of HIC cracks observed in the selected  $\times 65$  material after standard HIC test.

Hydrogen induced cracking was observed after cross-section of the  $\times 65$  steel test coupons after exposure to the standard test environment specified in NACE TM0284). An example of internal crack observed is given in Fig. 6.

- Crack length ratio (CLR):  $43.1 \pm 12.9\%$
- Crack thickness ratio (CTR):  $5.2 \pm 2.0\%$
- Crack sensitivity ratio (CSR):  $1.2 \pm 1.0\%$

According to ISO 15156, a pipeline material is acceptable for sour service if all the following criteria are met:  $CLR \leq 15\%$ / $CTR \leq 5\%$ / $CSR \leq 2\%$ . Therefore, the selected alloy is clearly not acceptable for sour service and susceptible to cracking in the presence of  $H_2S$ , i.e., in conditions encouraging high hydrogen uptake.

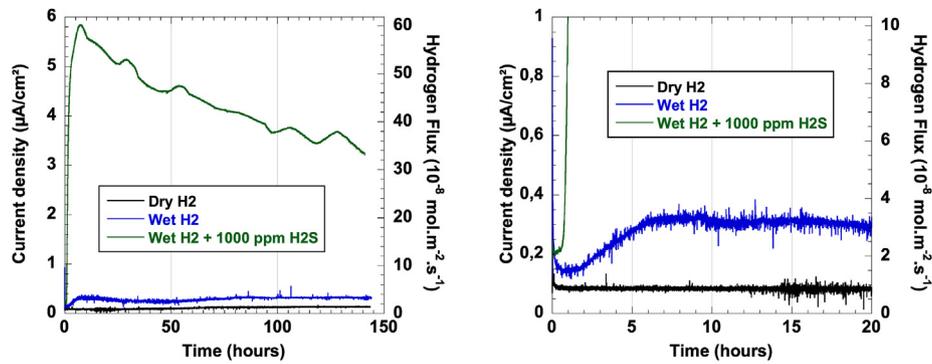
Fig. 7 – Permeation test result in the different test conditions selected. Membrane thickness 2 mm. (a): during 150 h. (b): zoom on the first hours of exposure.

Fig. 7 compares the hydrogen permeation flux through a 2 mm thick membrane exposed to each of the 3 conditions considered in the work. Several replicates of each condition were performed and there is some scattering in the test results. For instance, the steady state current under dry  $H_2$  varied in the range 0.1–0.3  $\mu A/cm^2$ , in presence of humidity in the range 0.1–0.5  $\mu A/cm^2$  and with humid  $H_2S$  reached always several  $\mu A/cm^2$ . Therefore, only a selection of representative experiments was considered in the figure to ease the understanding of the reader.

Nonetheless, the general hydrogen permeation trends are clearly visible after multiple experiments. The rate of hydrogen uptake in wet  $H_2$  is slightly higher than that observed in dry  $H_2$ . Contamination with  $H_2S$  is even more critical, generating a permeation flux at least one order of

magnitude higher than those measured in both conditions without  $H_2S$ . It is also obvious that humid hydrogen is a media that is slightly more severe than dry hydrogen regards the risk of hydrogen embrittlement, and the role of corrosion towards easing hydrogen uptake becomes relevant. The presence of  $H_2S$  renders the environment even more critical. In this latter case, we expect that the wet  $H_2S$  that is the cause of the hydrogen uptake is mechanistically different (possibly electrochemical charging at the surface from corrosion) instead of only the hydrogen from a gas phase. The contribution of the hydrogen gas is possibly limited.

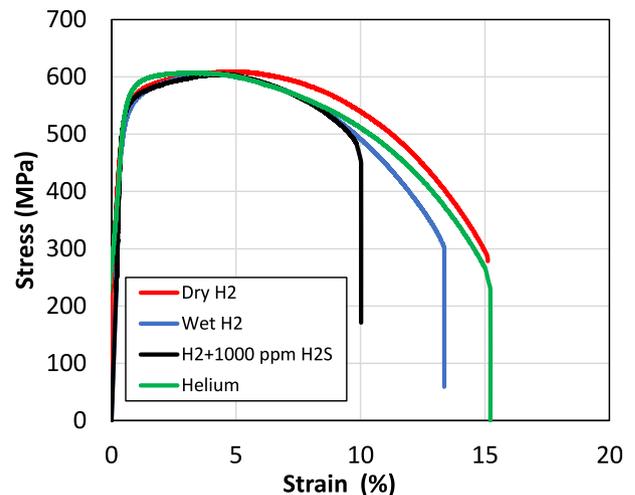
Fig. 8 – Slow strain rate test results in the different conditions selected.

The stress-strain behaviour in the elastic zone is comparable in all 4 cases, and indeed up to UTS. Hydrogen embrittlement is manifested after the initiation of necking. Indeed, the literature shows that the necking produces stress and strain localization and likely ruptures the native oxide layer present at the surface of the specimens that favors localized hydrogen intake and thus embrittlement [54–56]. The effect of hydrogen is stronger on notched specimens, and even more on cracked specimens, because the stress and strain localization are large at the notch root and even larger at the crack tip [57–59]. This recurrent conclusion from the literature is also evident in the rising step load tests for fracture toughness described in the next section.

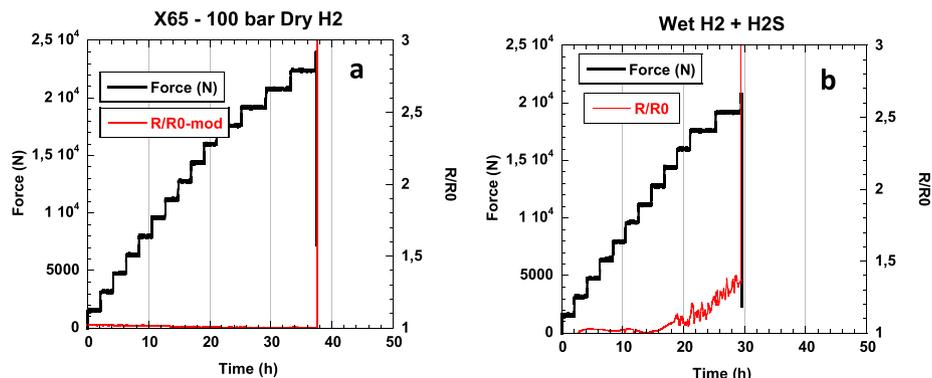
Fig. 9 – Example of monitoring during RSL tests. (a): Test under dry H<sub>2</sub>. (b) Test under wet H<sub>2</sub> and H<sub>2</sub>S contamination.

Fig. 9 presents the monitoring recorded during a RSL test completed under dry H<sub>2</sub> and another under wet H<sub>2</sub> with H<sub>2</sub>S contamination. The advantage of the RSL test against the SSRT is HE susceptibility from local hydrogen uptake can be distinguished with greater sensitivity (native oxide rupture/repair during dynamic straining). These data highlight that

two different behaviors can be observed depending on the test environment. When loaded under dry hydrogen, Fig. 9 (a), the ECGM monitoring ( $R/R_0$ ) indicates that the crack does not propagate before the last force step (23.5 kN) at which a sudden failure is observed. The crack propagation mode is therefore critical when the dry hydrogen  $K_{IH}$  level is reached. On the contrary, under wet hydrogen with H<sub>2</sub>S contamination, the ECGM ( $R/R_0$ ) highlights that the measured electrical resistance across the material starts increasing at and beyond an applied force of 15 kN while the final failure occurs at about 19 kN. A sub-critical crack propagation initiates therefore before the final failure. Thus, the parameters corresponding to this step when the propagation starts that ought to be employed for the  $K_{IH}$  calculation.

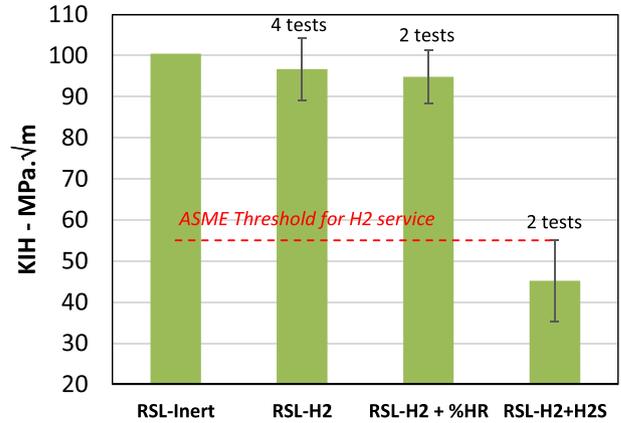
Fig. 10 –  $K_{IH}$  measured on  $\times 65$  under dry/wet H<sub>2</sub> or under wet H<sub>2</sub> with H<sub>2</sub>S contamination.

The drop in fracture toughness under 100 bar of dry H<sub>2</sub>, is moderate and approximately 5–10%. The drop is quite comparable in the presence of humidity.

With H<sub>2</sub>S contamination, the  $K_{IH}$  value becomes non-acceptable for hydrogen service according to ASME BPVC as per the fracture mechanics-based design approach.

Indeed, this standard specifies that any grade dedicated to H<sub>2</sub> service shall have a minimum  $K_{IH}$  of 50 ksi $\sqrt{\text{in}}$  (55 MPa $\sqrt{\text{m}}$ ). With 1000 ppm of H<sub>2</sub>S contamination, the  $K_{IH}$  measured is only 40 MPa $\sqrt{\text{m}}$  corresponding to a drop of more than 60% of the fracture toughness compared to the reference condition.

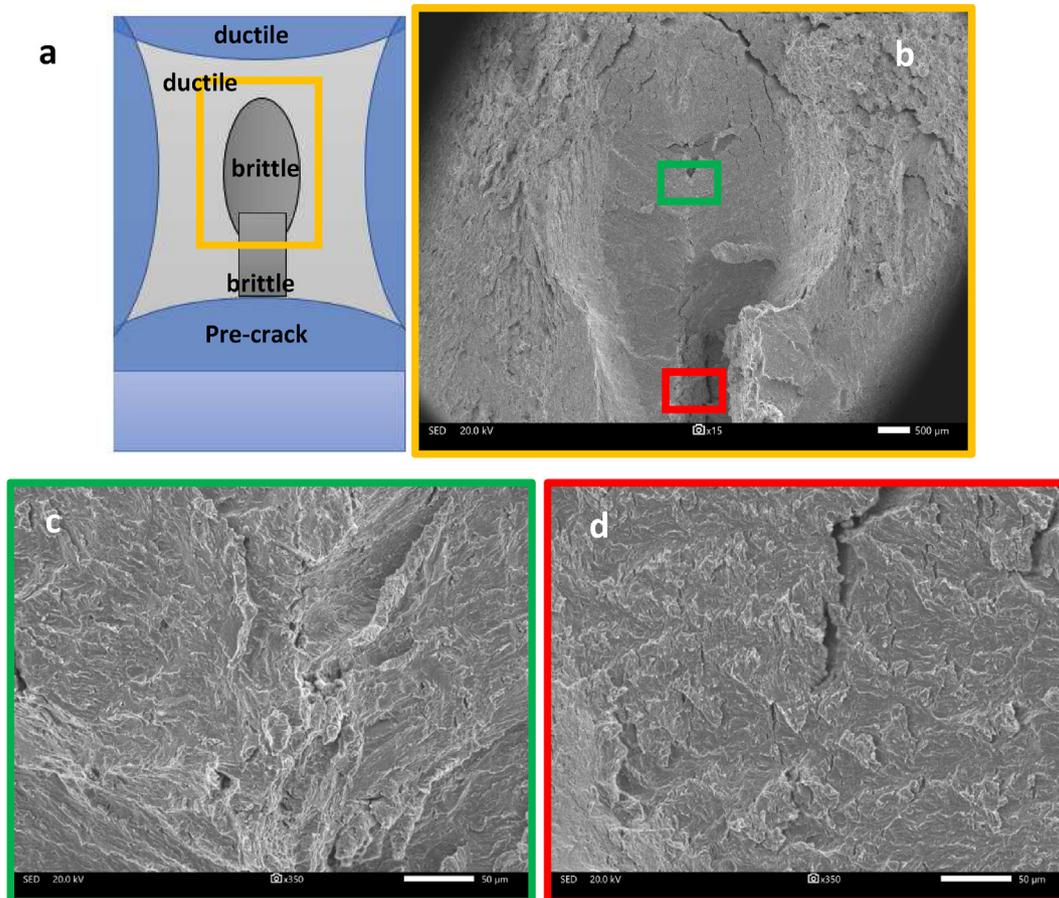
**Fig. 11** – Fractographic observations of the CT specimen tested under 100 bar of dry H<sub>2</sub> with RSL. (a): cartoon of fractured surface observations. (b-c-d): SEM observations of the areas highlighted by rectangles on the figures(a) and (b) showing how the brittle fracture propagated in the middle of the specimen and ductile failure on the edges.

After test under hydrogen, dry, or wet, the fractured surface is very comparable. A brittle crack propagation initiated from the fatigue pre-crack tip but the propagation did not proceed homogeneously along the width of the specimen. The surface is rather clearly brittle in the core of the specimen and ductile on the edges. The brittle fracture extends far in the center of the specimen, with thick plastically deformed edges. This could be due to a preferred diffusion of hydrogen in the

central region, where the hydrostatic stress is high, promoting a brittle fracture there. In the example presented, the brittle crack initiated in the center but homogeneous crack initiation along the pre-cracked front were also obtained in test replicates, with reproducible higher brittleness in the center.

For the specimens tested with and without  $H_2S$  addition (Figs. 11 and 12) an oval-shaped brittle area can be seen some millimeters ahead the tip of the pre-crack. The

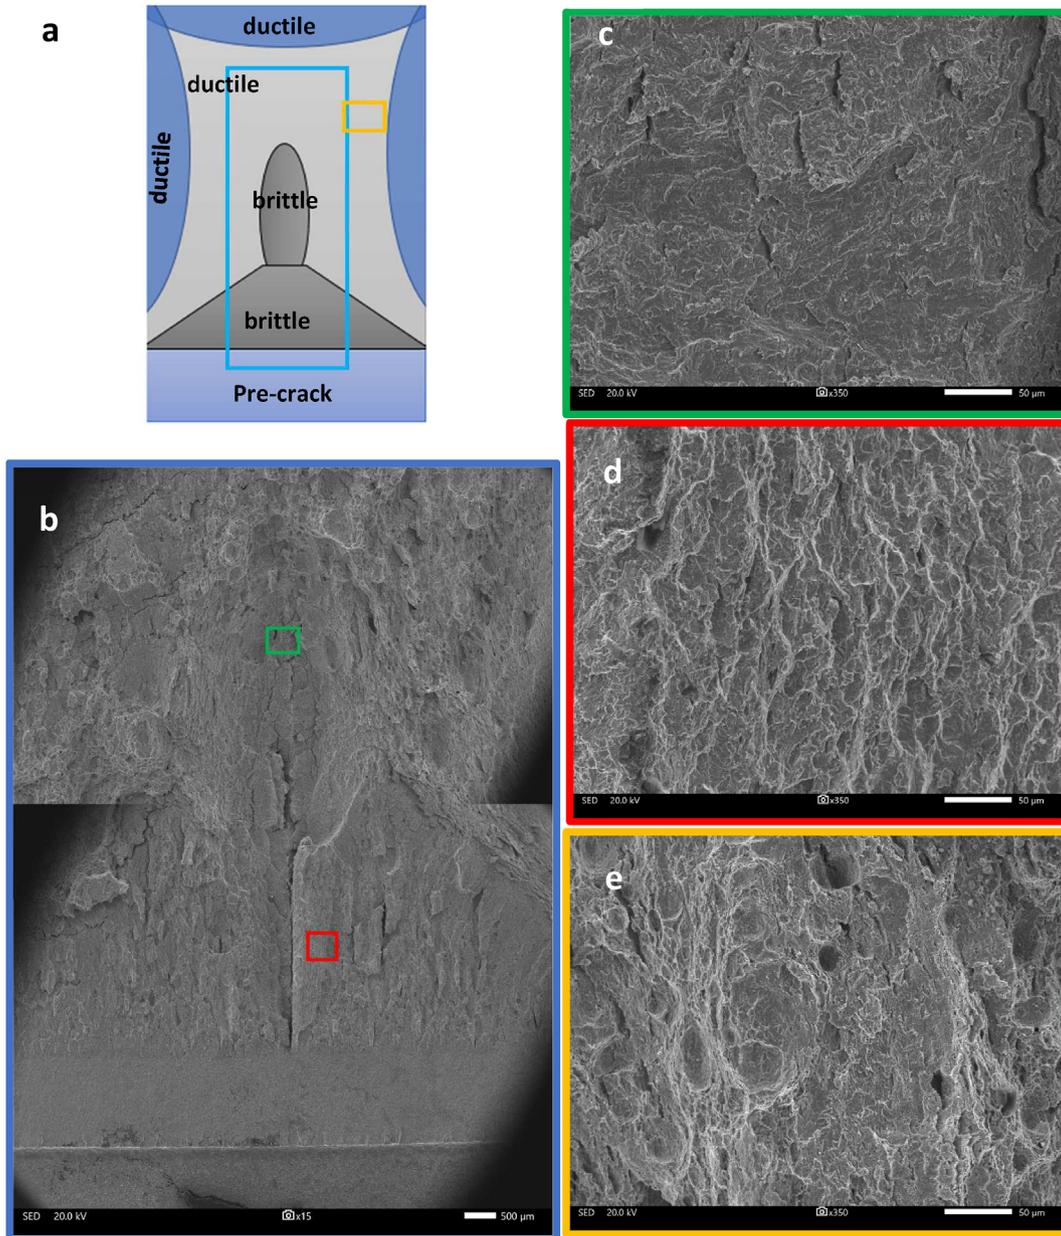
**Fig. 12 – Fractographic observations of the CT specimen tested under 100 bar of wet  $H_2 + H_2S$  with RSL. (a) cartoon of what is observed on the fractured surface. (b-c-d): SEM observations of the areas highlighted by rectangles on the figures (b) and (c) showing an initial brittle propagation crack followed by a ductile final fracture. (d) evidence of MVC on the non-pre-cracked edge suggesting ductile failure at this site.**

After tests in wet hydrogen with H<sub>2</sub>S contamination, the fractured surface is completely different. The expected homogeneous transgranular crack propagation is visible, which in this case advanced until the remaining material ligament was too short to sustain the tensile stress applied, thus leading to a final ductile fracture. Here, no deep extension of the brittle zone is noted within the central part of the ruptured specimen, as previously observed in the tests without H<sub>2</sub>S. This could be due to a smaller sensitivity of hydrogen diffusion to hydrostatic stress, or more simply, to the relatively lower value of the hydrostatic stress, as the fracture load was much lower than for the other tests.

hydrostatic stress concentration ahead a crack tip is suggested to be confined within the first 500  $\mu m$  [64]. Thus, this pattern could not be explained by local hydrogen oversaturation prior to cracking due to the stress triaxiality. An effect of elemental macro-segregation cannot be ruled out considering the sampling location of the CT at mid-wall thickness of the pipelines.
